All that tract or parcel of land lying and being in Land Lot 77 of the 14th District, City of Atlanta, Fulton County, Georgia and being more particularly described as follows:

Site Address: 237 Peachtree Street SW Atlanta, GA 30303

DATE: OCTOBER 3, 2012 SCALE: 1"=20'

Sheet No. 1 of 1

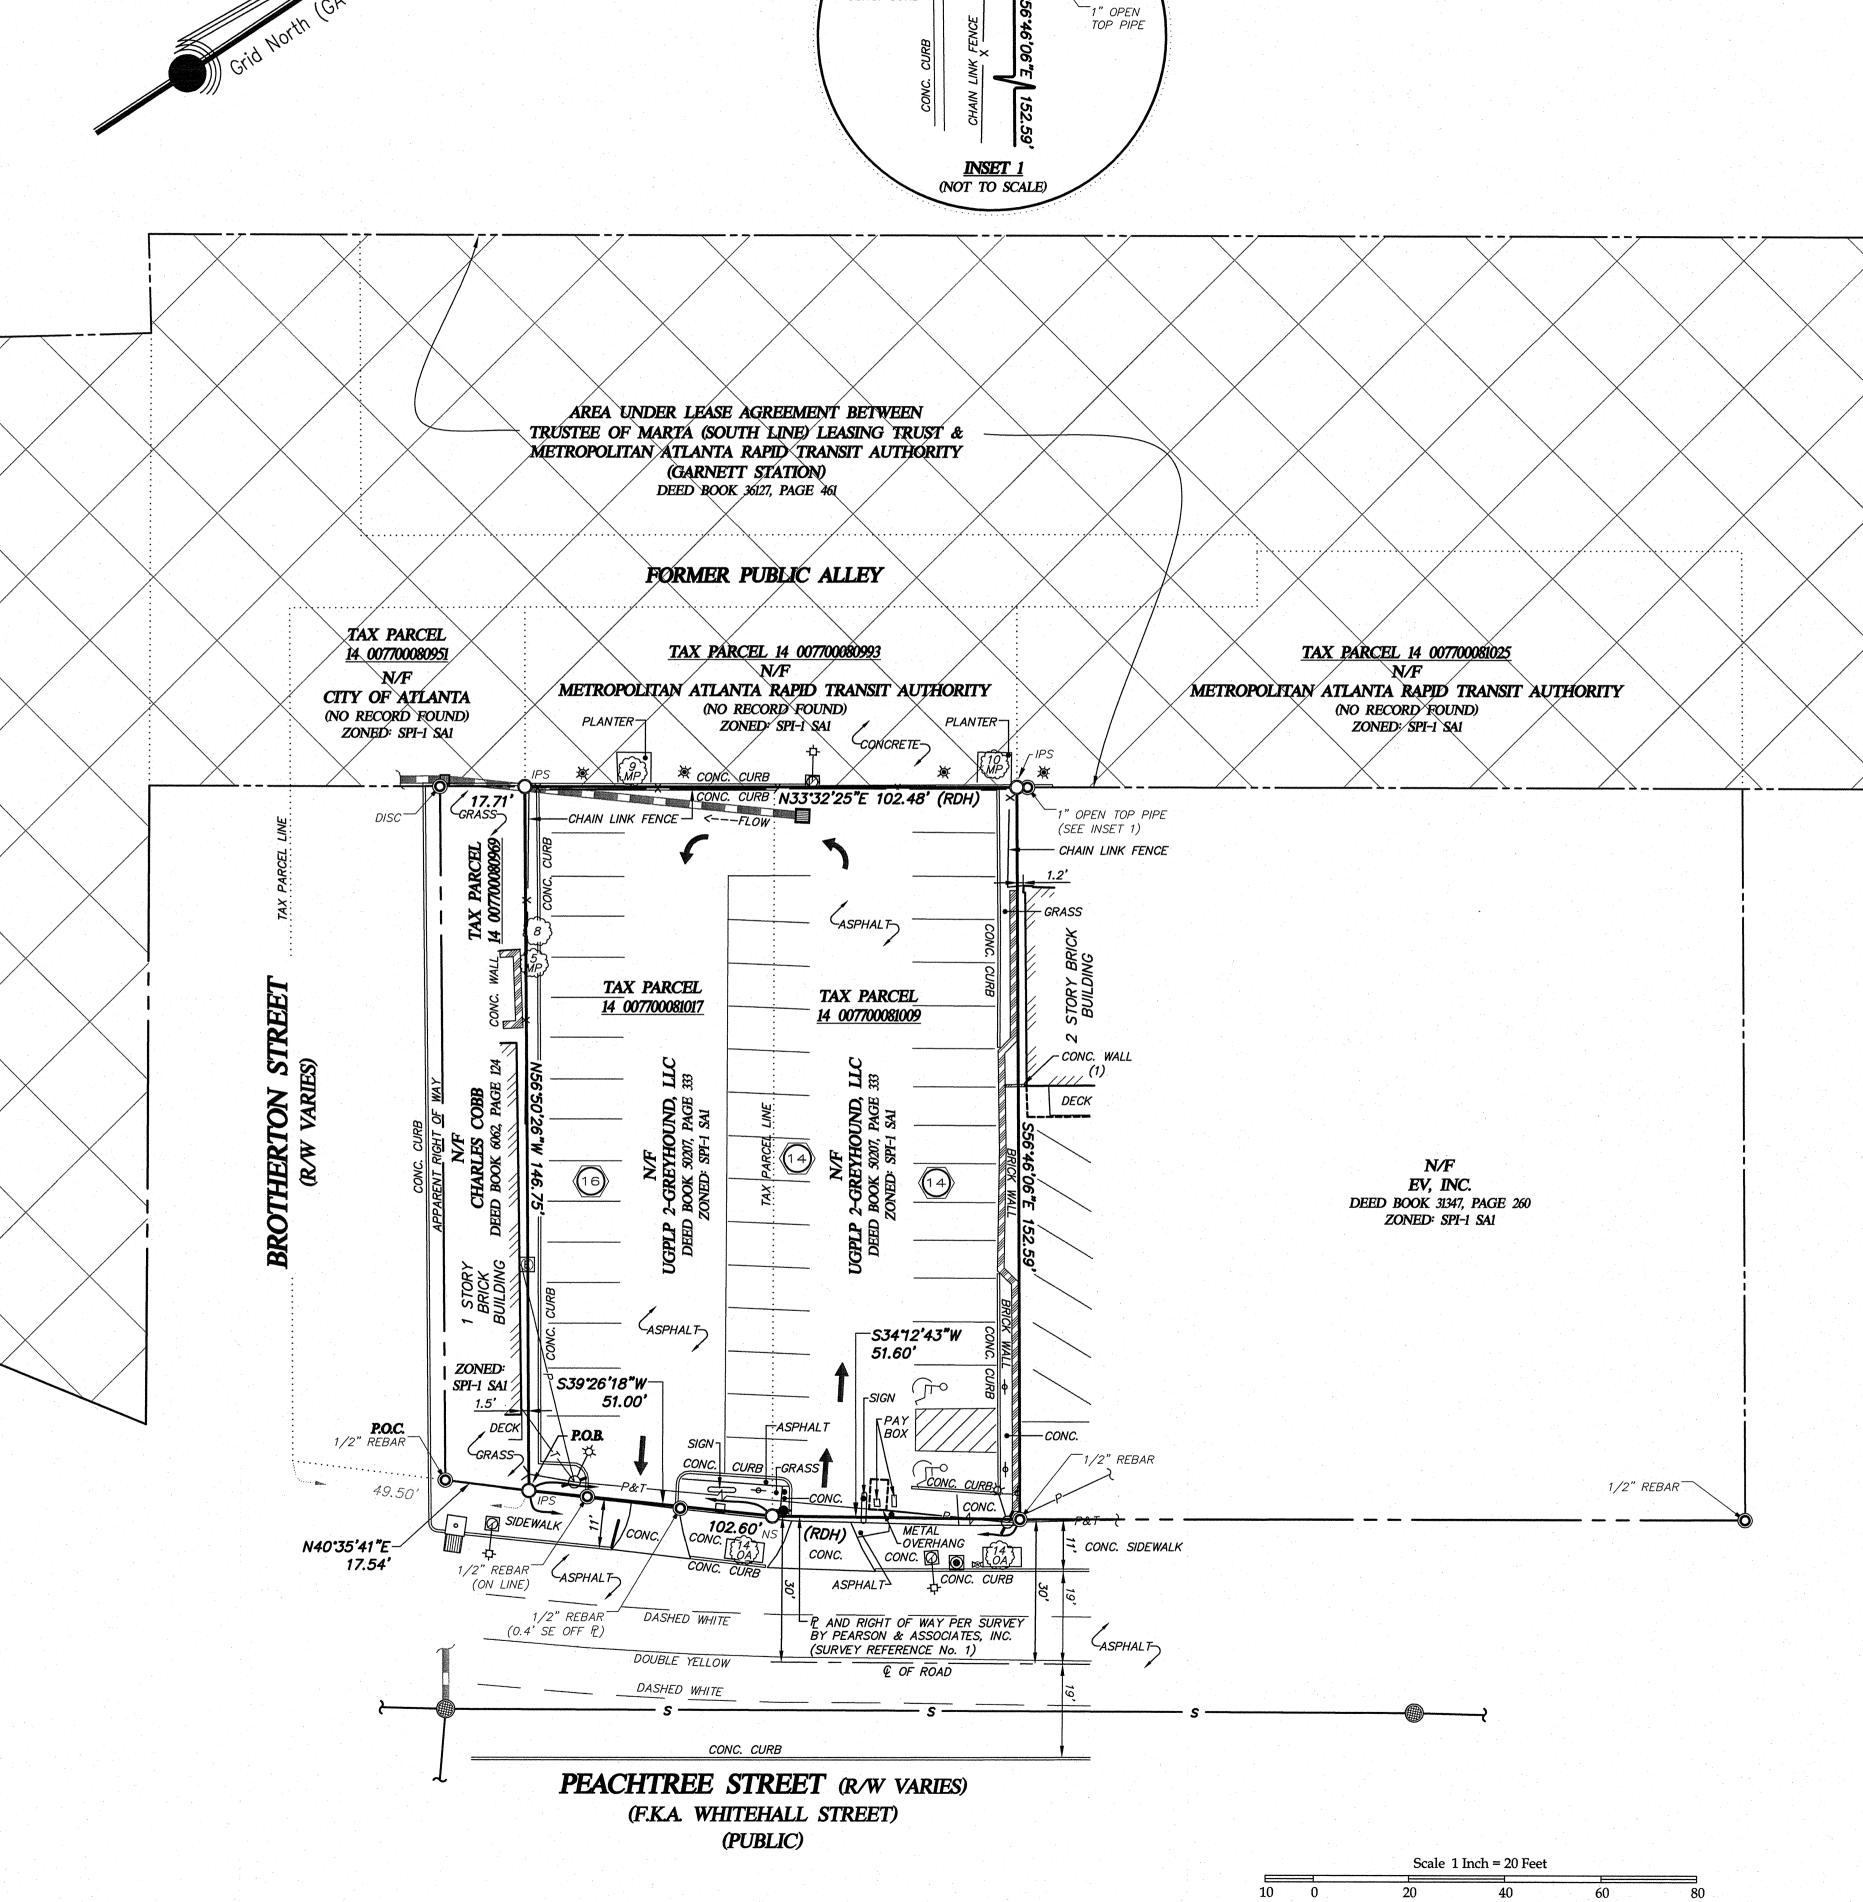
Possible Encroachments:

(1). Concrete Wall along the northeasterly boundary line of Subject Property.

Area Summary: 0.35 acres or 15,443 square feet

Parking Summary: Regular Parking Spaces: Handicap Parking Spaces: 2 Total Parking Spaces:
